Inspection Tech Home Inspection Report

Property Address:

1234 Easy Street

Inspected on Mon, Jun 13 2011 at 8:00 AM

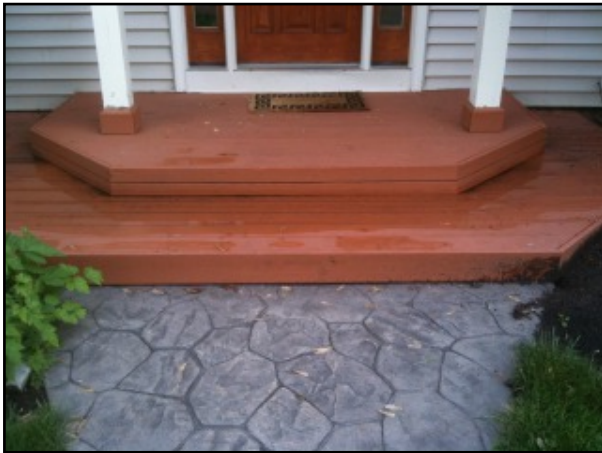
Figure 1-1

**Comment 1:**
Step is improperly pitched and water is ponding. Recommend repair.

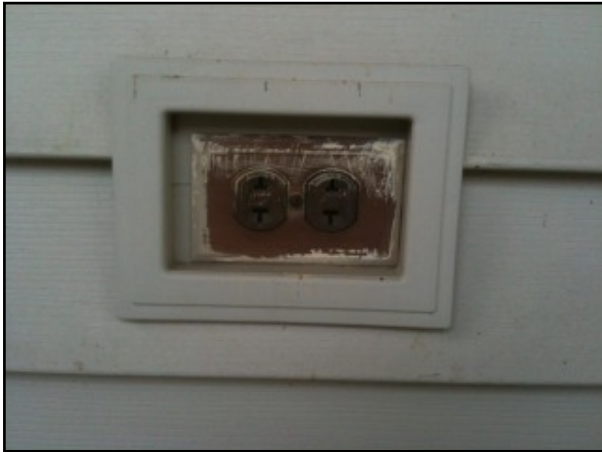
Figure 2-1

**Comment 2:**
Ungrounded outlet outside. SAFETY HAZARD. Recommend upgrading to a GFCI protected outlet.

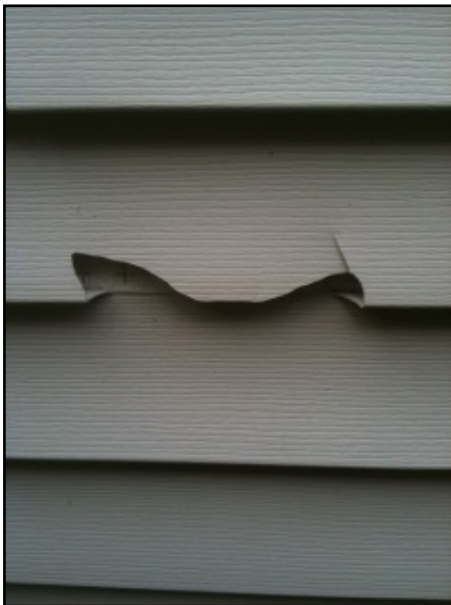
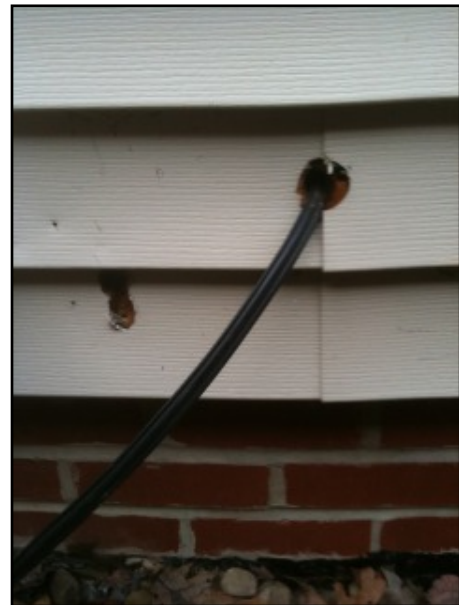
Recommend repair and seal siding to prevent infestations.

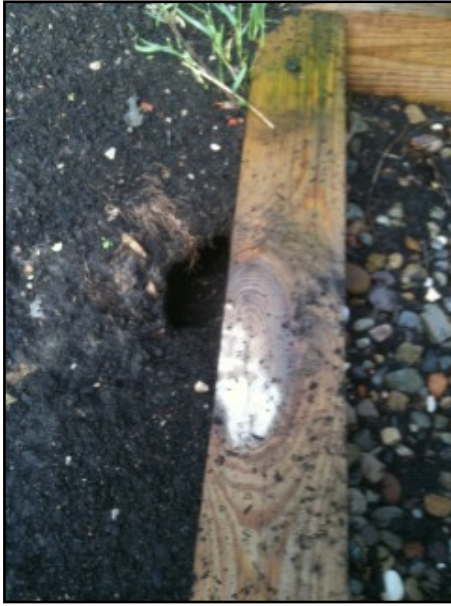
Figure 4-1

Several burrow holes around house. Recommend pest/rodent inspection.

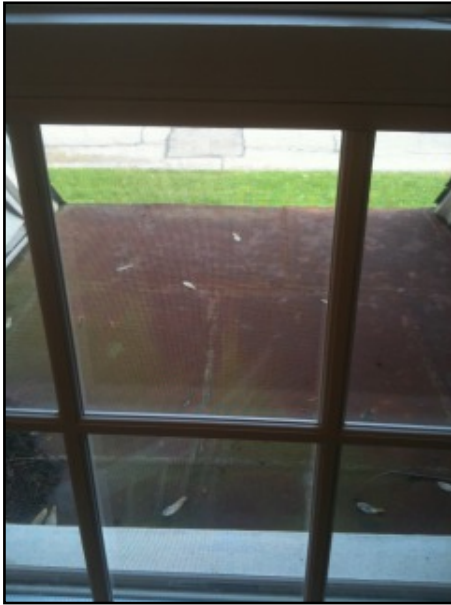
Figure 5-1

Comment 5:
Metal roofing is rusted and in need of repairs.

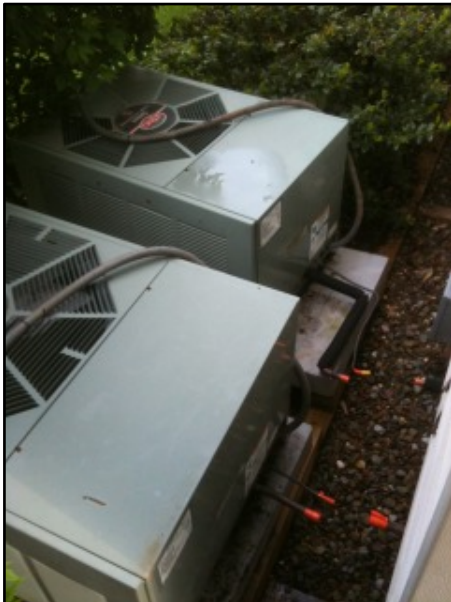
Figure 6-1

Both A/C units disconnected at time of inspection due to repairs being made to basement.

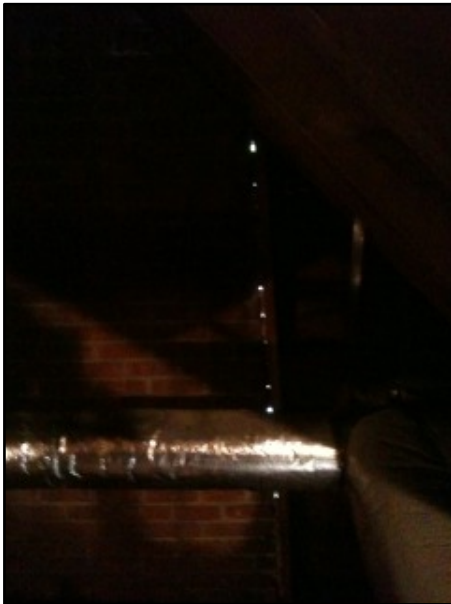
Figure 7-1

Light can be seen on both sides if chimney. Recommend sealing.

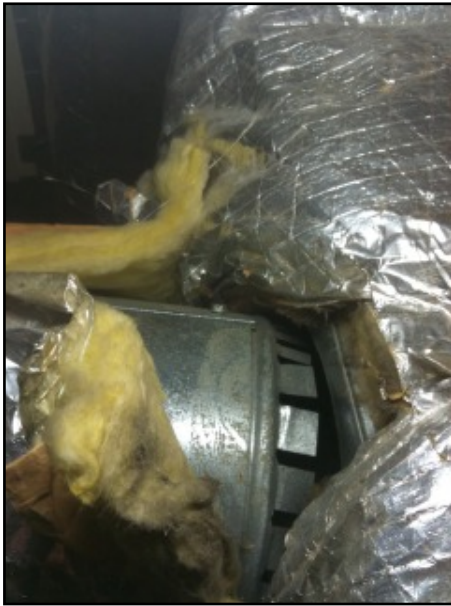
Figure 8-1

Loose cooling duct in attic. Recommend repair.

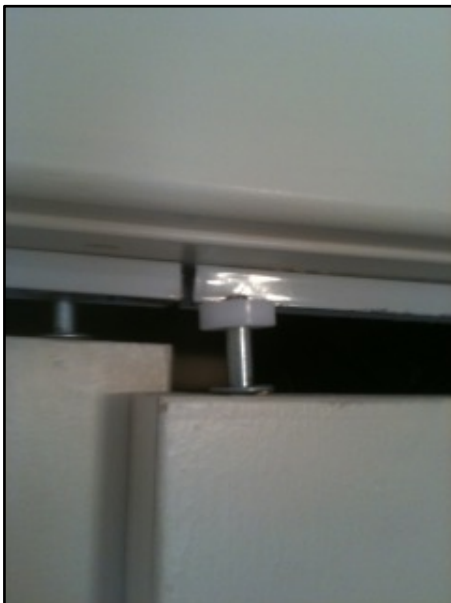
Figure 9-1

Comment 9:
Closet door off track.

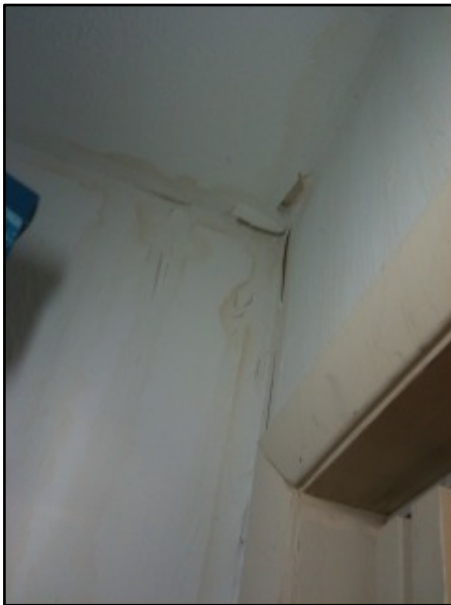
Figure 10-1

Comment 10:
Water damage in closet.

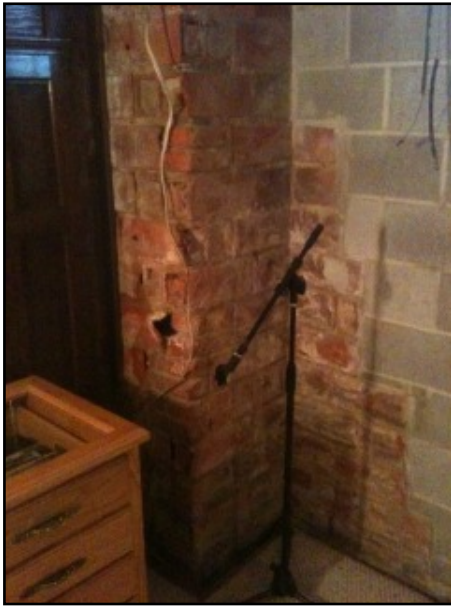
Figure 12-1

Walls & Ceilings:	Poor, Holes in walls
Flooring:	Satisfactory, Squeaks
Ceiling Fan:	N/A
Electrical:	Switches operate, Outlets operate
Heat Source Present:	Yes
Doors & Windows:	Satisfactory

Being repaired.

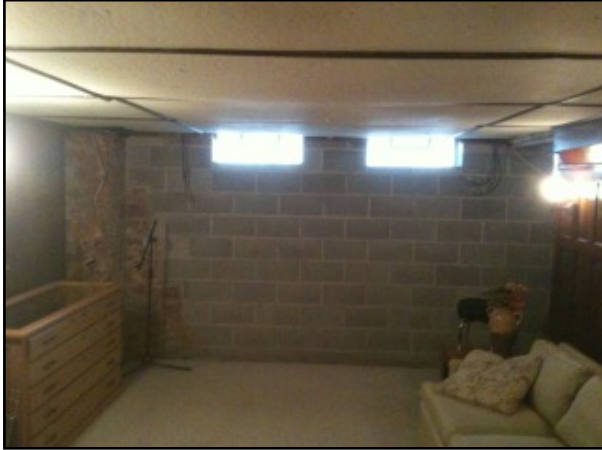
Figure 13-1

Comment 13:
Loose electrical wires. Being repaired.

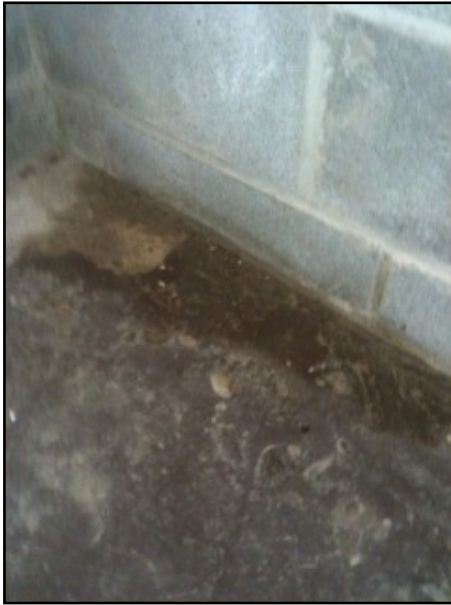
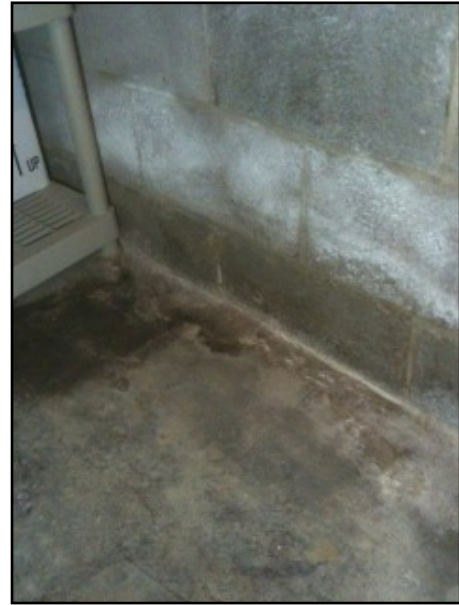
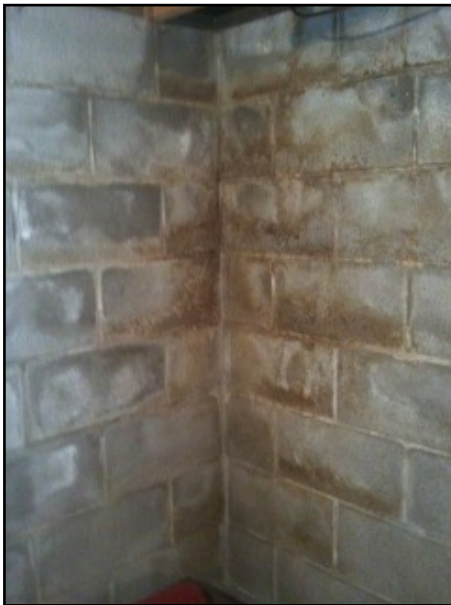
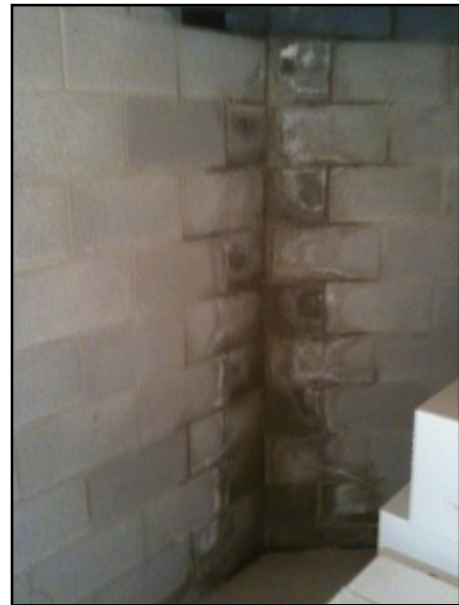
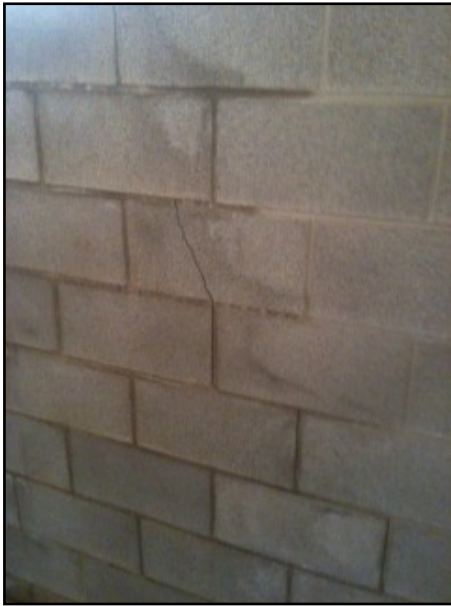
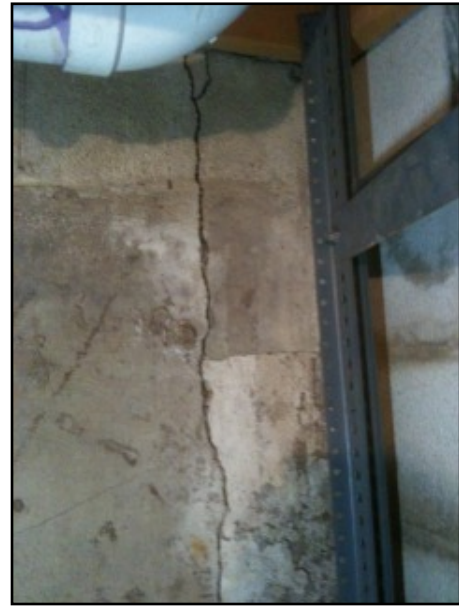
Basement walls have several cracks, movement and moisture. Recommend repairs.

Building Material:	Concrete block
Horizontal Cracks:	West, East
Vertical Cracks :	None
Step Cracks :	West
Movement Apperant :	West, East
Covered Walls:	North , West
Condition:	Poor

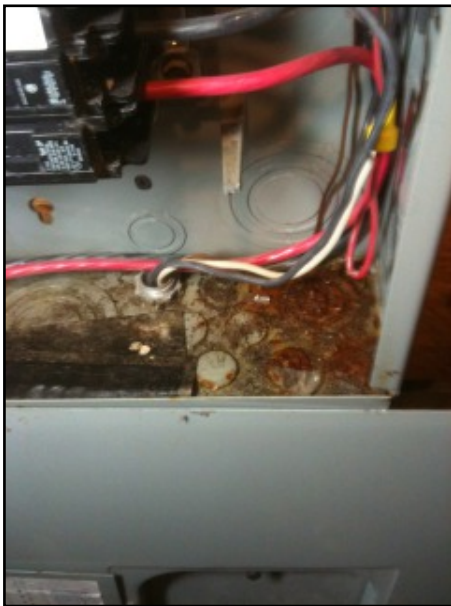
Figure 17-1

Rusting and moisture present in the electrical panel.

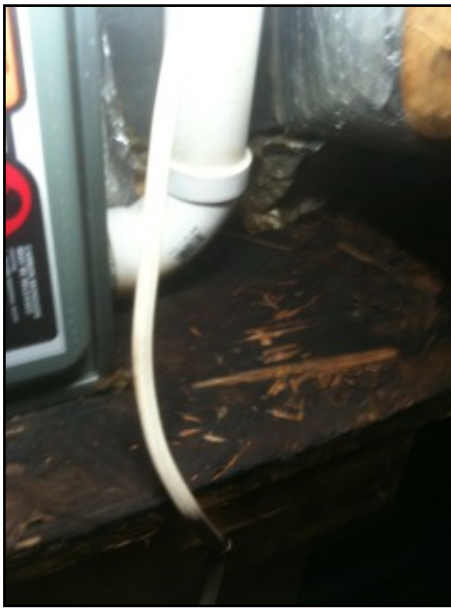
Figure 18-1

OSB board that attic furnace sits on appears to be charred. Reason unknown.

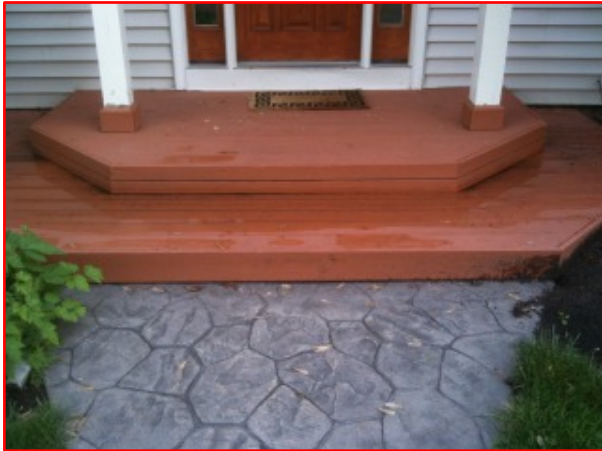
Figure 1-1

1) Step is improperly pitched and water is ponding. Recommend repair.

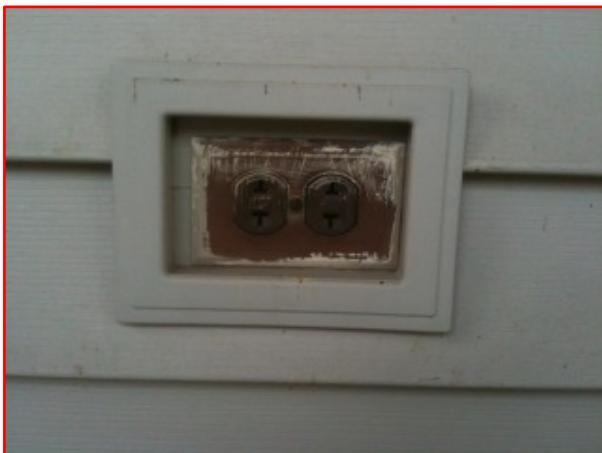
Figure 2-1

2) Ungrounded outlet outside. SAFETY HAZARD. Recommend upgrading to a GFCI protected outlet.

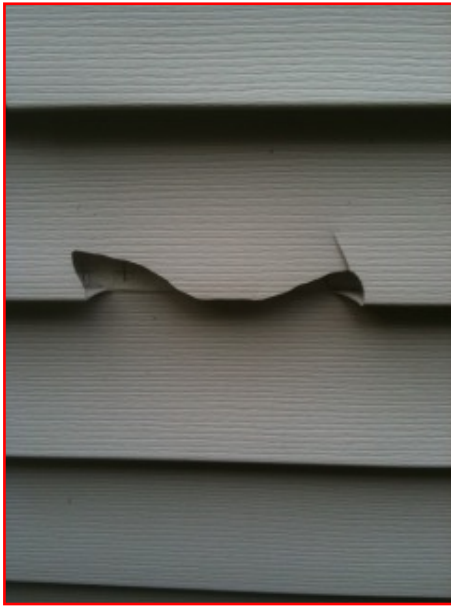
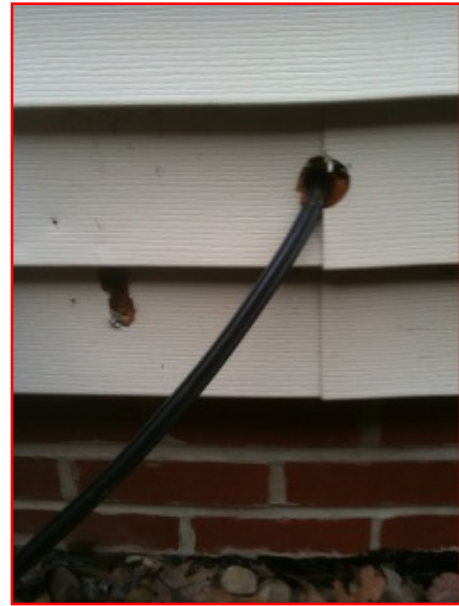
3) Recommend repair and seal siding to prevent infestations.

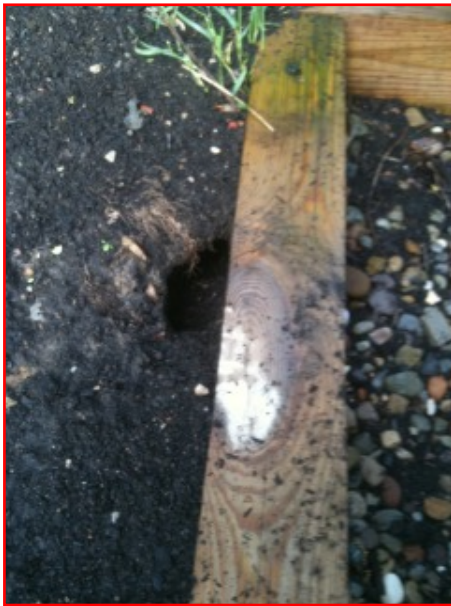
Figure 4-1

4) Several burrow holes around house. Recommend pest/rodent inspection.

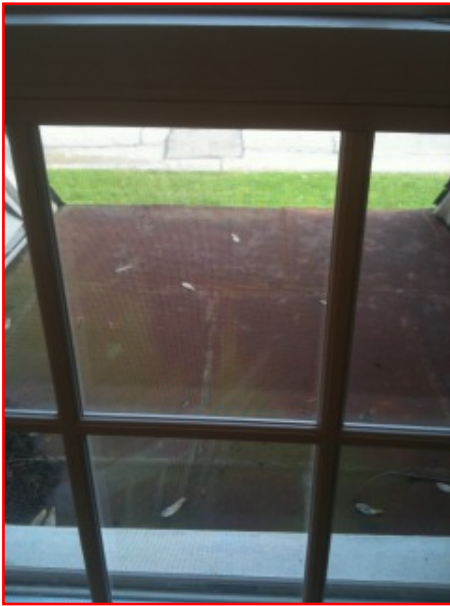
Figure 5-1

5) Metal roofing is rusted and in need of repairs.

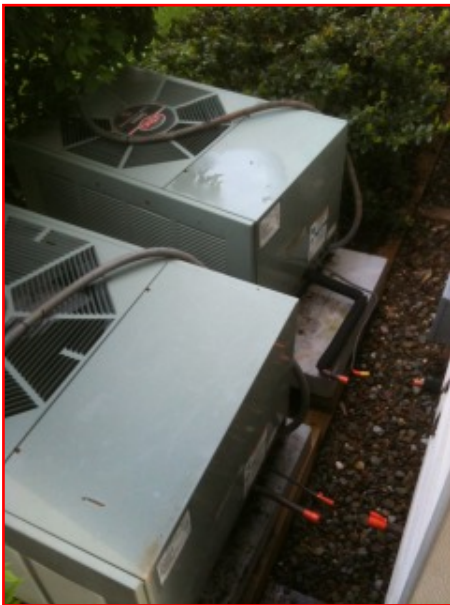
Figure 6-1

6) Both A/C units disconnected at time of inspection due to repairs being made to basement.

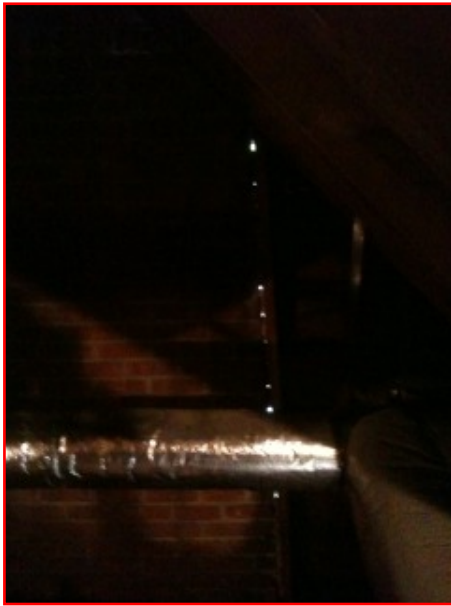
Figure 7-1

7) Light can be seen on both sides if chimney. Recommend sealing.

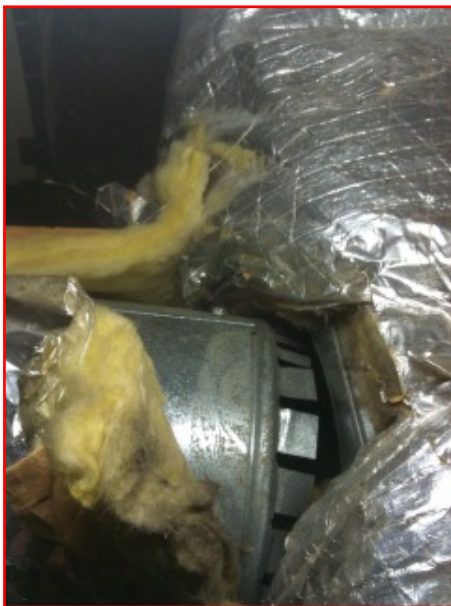
Figure 8-1

8) Loose cooling duct in attic. Recommend repair.

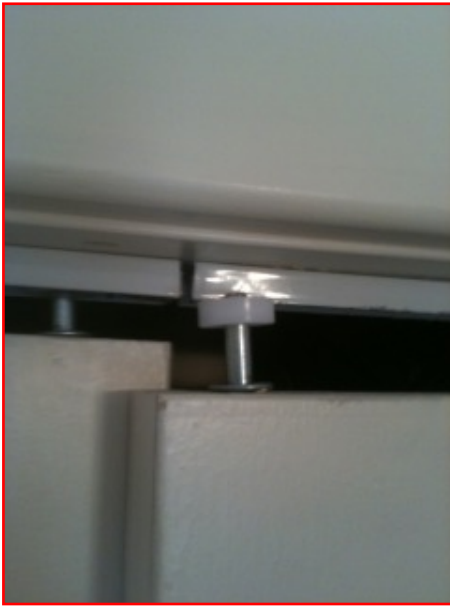
Figure 9-1

9) Closet door off track.

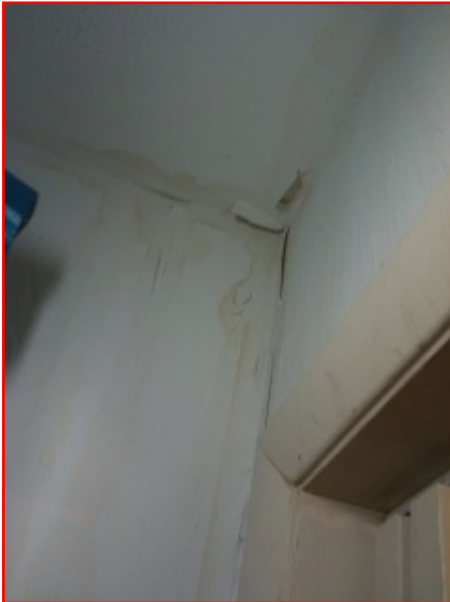
Figure 10-1

10) Water damage in closet.

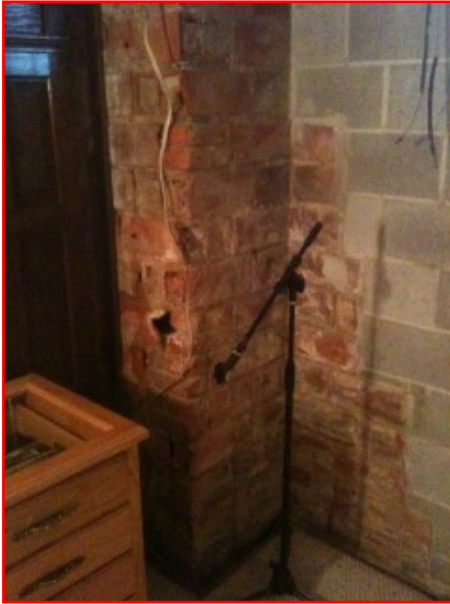
Figure 12-1

12) Being repaired.

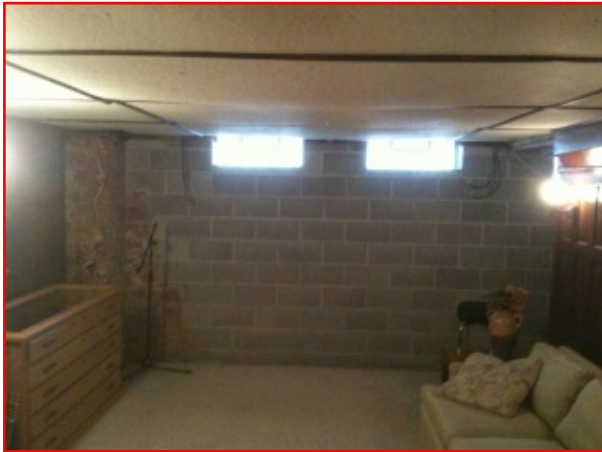
Figure 13-1

13) Loose electrical wires. Being repaired.

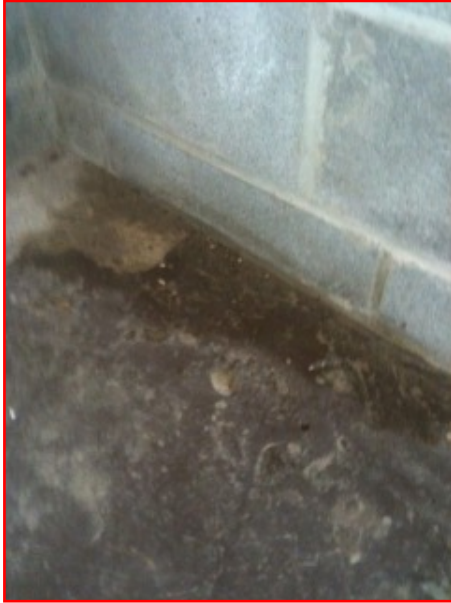
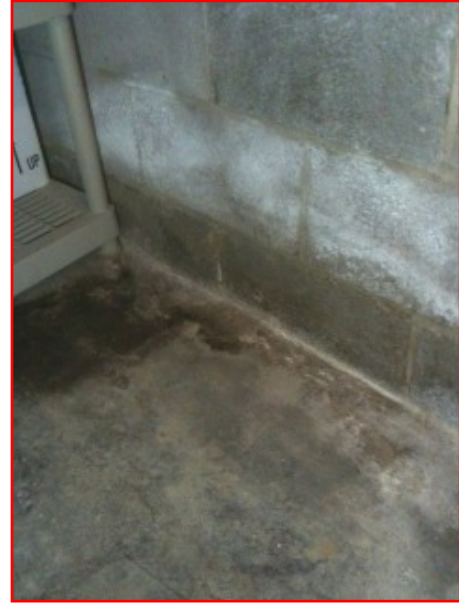
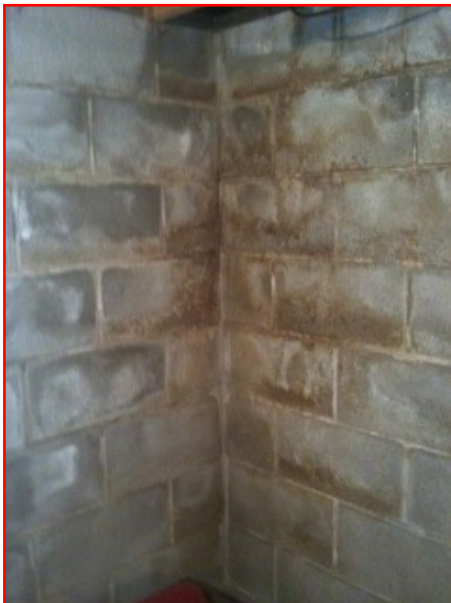
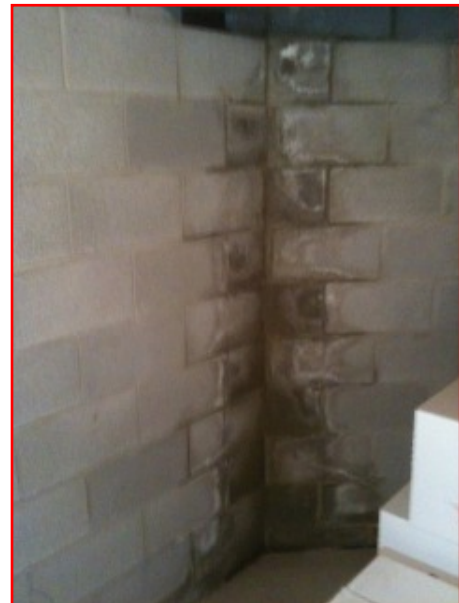
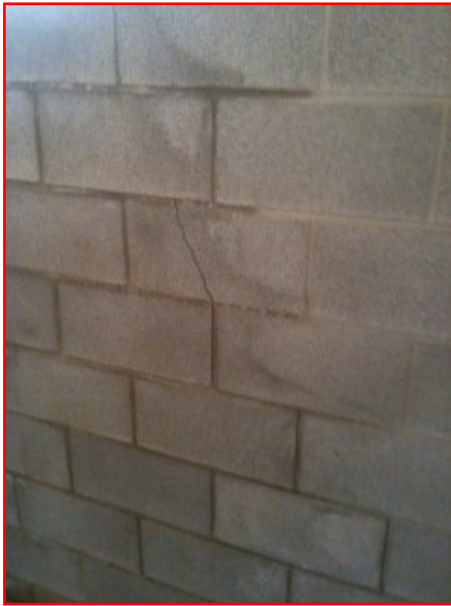
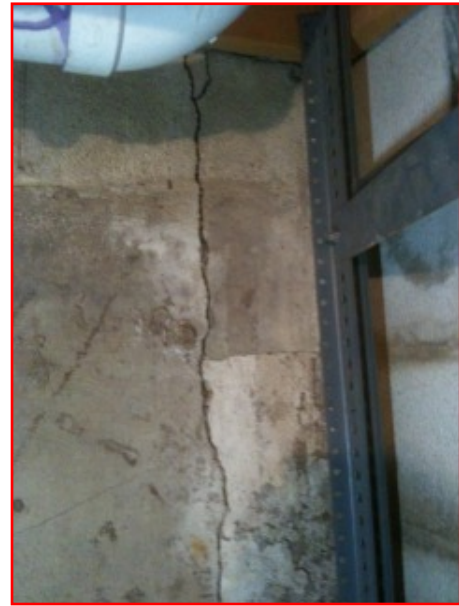
16) Basement walls have several cracks, movement and moisture. Recommend repairs.

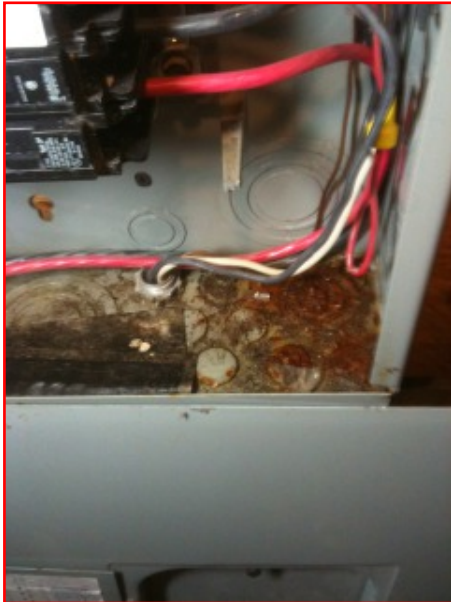
Figure 17-1

17) Rusting and moisture present in the electrical panel.

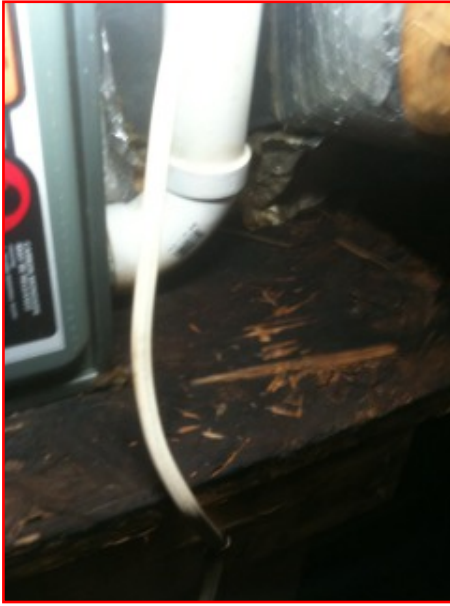
Figure 18-1

18) OSB board that attic furnace sits on appears to be charred. Reason unknown.
